Prototype Bailey Approach SE motorhomes were tested at Millbrook Proving Ground

Bristol fashion

John Wickersham reports on the extensive testing undertaken by Bailey to ensure its new motorhomes were shipshape

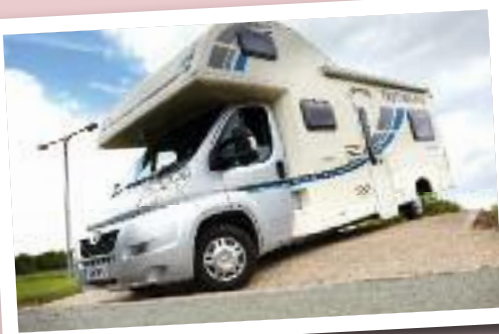
The lightweight Al-Ko Automotive Chassis (AMC) provides a low centre of gravity – this test confirms that it doesn't hit the ground when negotiating a tricky drive-way ramp

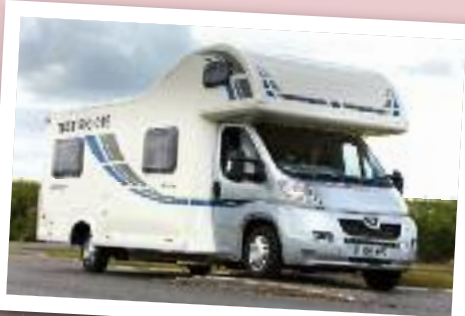
On first inspection, this looks like a standard speed hump, but it's much more testing. An angled structure adds a twisting action that can distort items inside or out

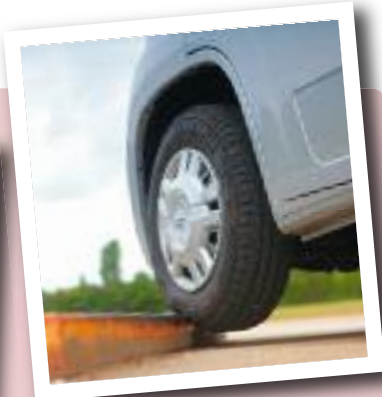
Over a period of years, owners often find it necessary to go over a kerbstone. It can be a tough test for tyres but this sharp edge causes no damage at all

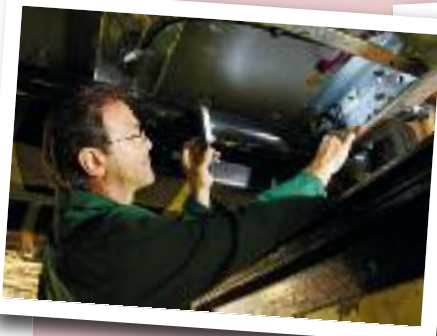
Throughout the two-week test, vehicles are strictly checked at pre-set intervals by Millbrook engineers. Workshop pits provide good access to the underfloor gear

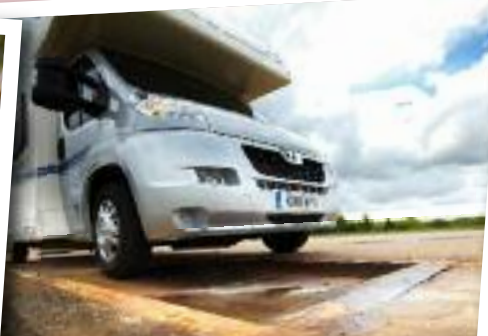
After last winter's frosts, roads were peppered with potholes. At Millbrook Proving Ground, these carefully-crafted obstructions form part of the six-year durability test

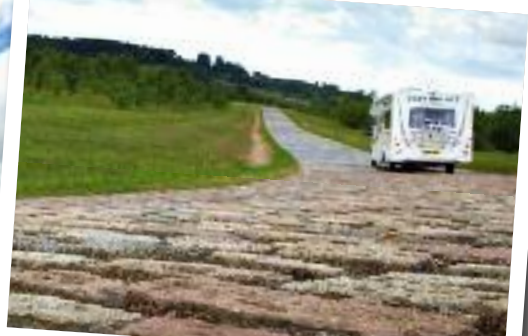
There are plenty of pavé road surfaces, too, some of which are far more destructive than the once-common roads that we tackled abroad. This is one of the mild ones at Millbrook

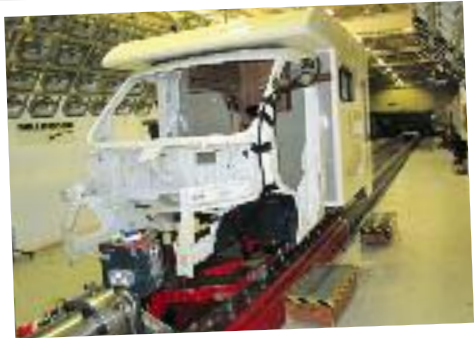
It takes several hours to mount a mock-up cab and habitation section to a wheel-less sled which rests on a track. Camcorders are mounted to record the results

Instead of propelling a mock-up at 30mph towards an obstruction, the obstruction rams the stationary structure. Preparation involved bolting the body structure to a heavy, steel sled. Four dummies were then placed inside – two 'adults' each weighing 75kg, one 'adult' weighing 54kg and a 'child' weighing 24kg. Each dummy was seated and belted; meanwhile, the observers retired to the safety of the viewing room.

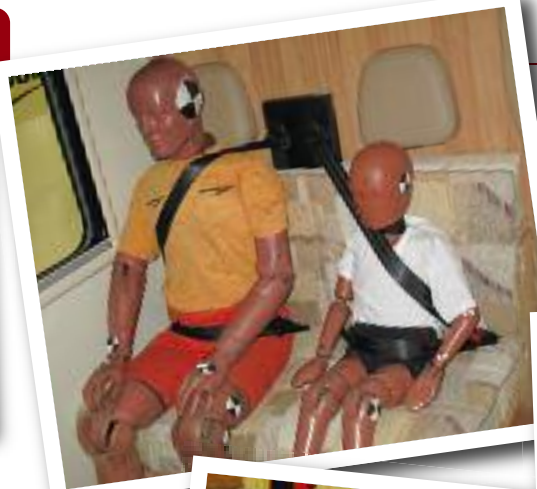
This mock-up uses an SE 760 (six-berth) seating arrangement in which four belted seats are provided behind the driver. The table is removed for the impact test*

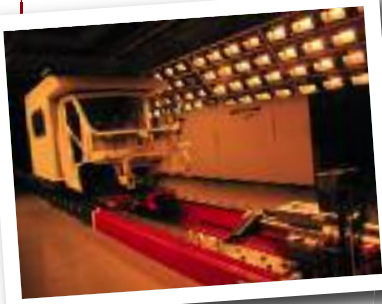
A piston drives into the sled and the assembly hurtles back down the track. Banks of lights illuminate the scene for the observers

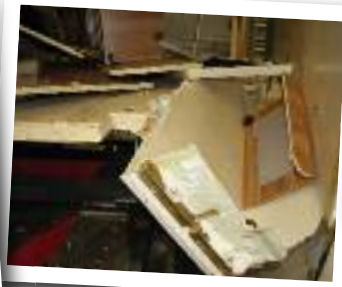
In the first test, a lack of outriggers outside the main chassis rails causes the floor to break lengthways. The fridge and cooker fall out

These crash tests (see top panel overleaf) were hugely important. An Alu-Tech structure is indisputably strong – however, the trials showed that to support a sandwich constructed floor across its full width, especially where it carries heavy kitchen appliances, chassis outriggers are crucial. But many motorhomes are built without them.

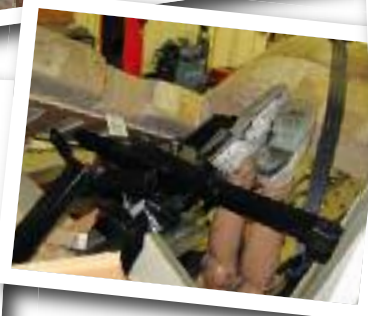
During this test, a bolt on the rear-facing TUV-approved safety belt structure sheers and its dummies shoot forward. This one falls headfirst through the broken floor

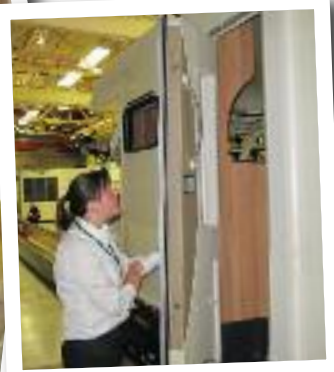
At the third test several weeks later, outriggers support the floor and the structure and kitchen are fine. The door operates, but a seatbelt frame distorts again

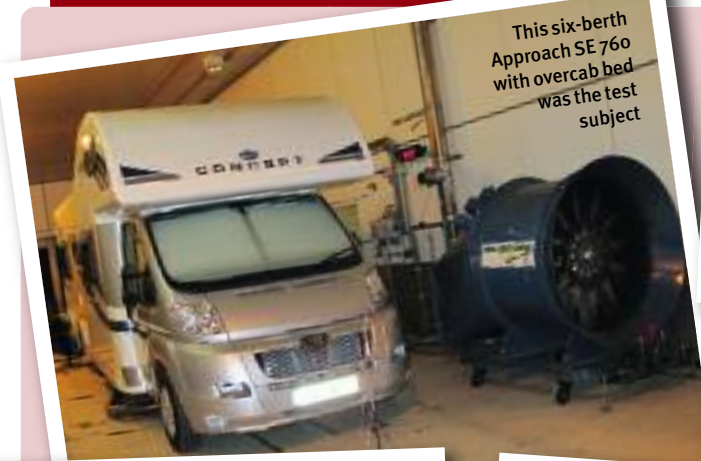
This six-berth Approach SE 760 with overcab bed was the test subject

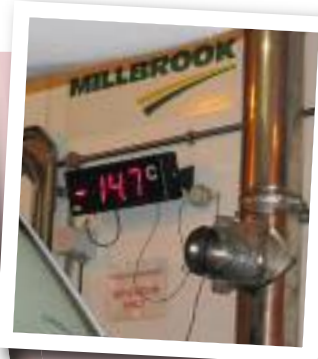
It takes around 10 hours to bring this large enclosure down to -15°C. The progress is monitored for observers to watch on a display screen

It's no easy task to achieve a Grade III classification for Thermal Insulation (EN1646-1). It takes 10 hours to bring a purpose-made building housing a

vehicle down to -15°C. Then the motorhome heating is switched on with the aim of raising its internal temperature to 20°C within four hours. Once this stabilises, fresh water is connected – the supply should be operational even when the external temperature is still -15°C.

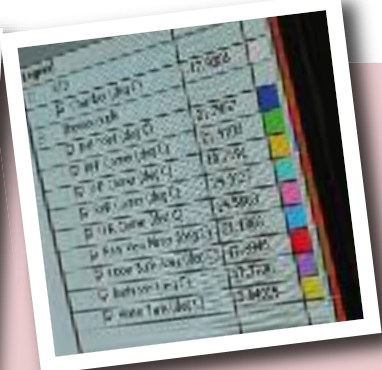
Inside the vehicle, nine temperature monitoring points are chosen and fitted with measuring equipment. Readings are reported in the viewing room

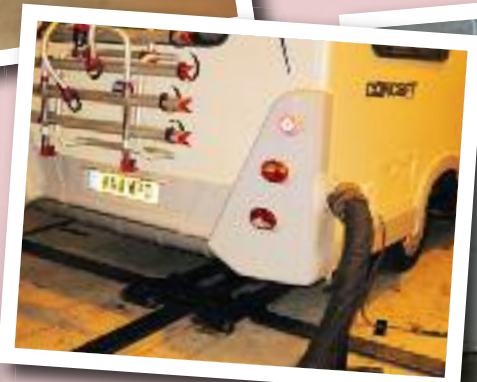
When the Truma Combi boiler is brought into action, fumes from the gas exhaust are removed through a flexible duct. Ice from condensation forms on the body

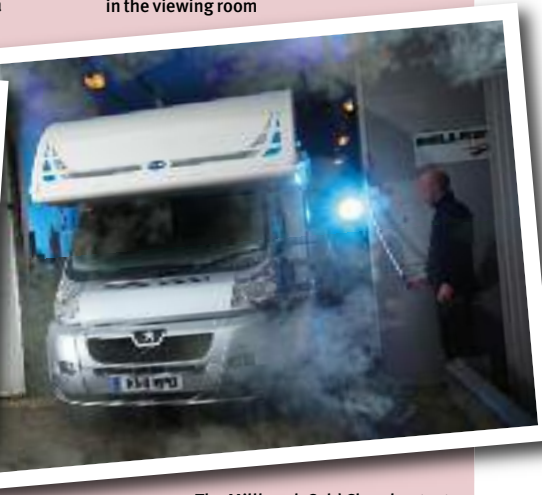
The Millbrook Cold Chamber test is a comprehensive one

Donning my quilted ski jacket on a warm, sunny day in August, I witnessed a successful cold chamber test (see bottom panel overleaf).
